New Jersey Landslides

Introduction

New Jersey Geological Survey

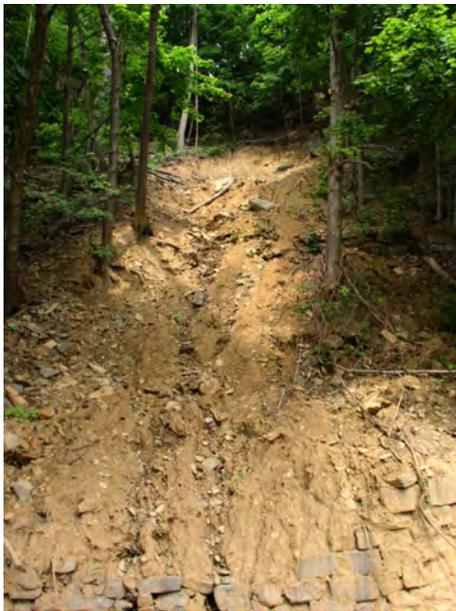
Figure 2. Scar of debris flow above Henry Hudson Drive, Alpine, Bergen County. Photograph by T. Pallis, N.J. Geological Survey.

April 15-16, 2007 - Several damaging landslides occurred during a northeaster. The most destructive one occurred in Lodi, Bergen County, along Farnham Avenue and was triggered by as much as eight inches of rain. Fifty families were displaced from six homes and an apartment building after they were deemed too dangerous to inhabit. A landslide also caused a highway accident on Route 208 southbound near Lincoln Avenue in Glen Rock, Bergen County. There were no injuries but the highway was closed until the vehicles and mud could be cleared. At least six landslides occurred along the Palisades in Bergen County from Fort Lee to Alpine, closing Henry Hudson Drive for over a month (fig. 2). Also, a small rockfall blocked traffic for a time along Sinatra Drive in Hoboken (fig. 3) and a small debris flow occurred in a residential area in Highlands Borough, Monmouth County (fig. 4).

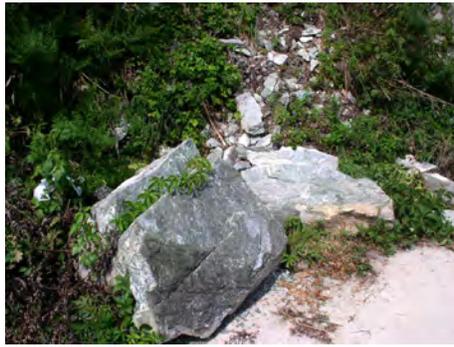
Figure 3. Small rockfall along Sinatra Drive, Hoboken, Hudson County. Photograph by T. Pallis, N.J. Geological Survey.

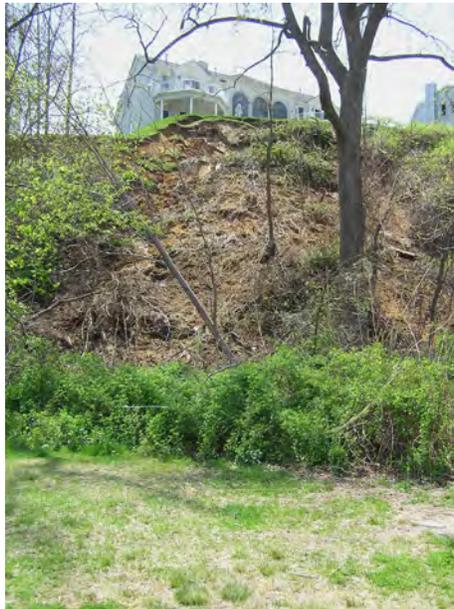
Figure 4. Landslide in Highlands Borough, Monmouth County, triggered by heavy rains from the April 15-16, 2007, northeaster. Photograph by S. Stanford, N.J. Geological Survey.

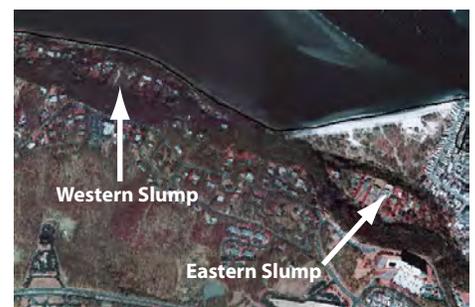
Figure 5. Aerial photograph with arrows showing the old slump blocks in the Atlantic Highlands area.

Today the western slump block (fig. 5) is 400 feet wide and 2,500 feet

long, the eastern one, 450 feet wide and 1,400 feet long (Minard,1969). The eastern slump block is the result of two large landslides in the past. The first included the entire mass, the second, a smaller section of the first dropped down farther (Minard,1974). These slump blocks are now stable and can be viewed from Mt. Mitchill Overlook,

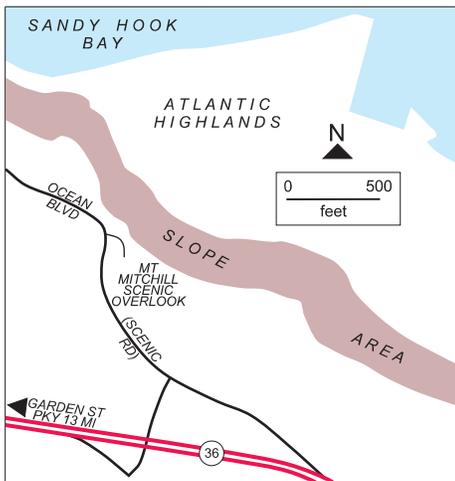
Figure 6. Map showing location of Mt. Mitchell Overlook, cartography by B. Graff.

a Monmouth County Park where there is also an interpretive plaque that explains the history of slumping in the Atlantic Highlands (fig. 6).

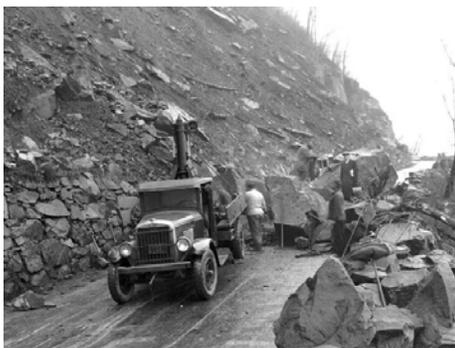
Figure 7. Photograph of a rockfall on Henry Hudson Drive March 8, 1933, in Bergen County. Photograph courtesy of "Palisades Interstate Park - NJ Section."

One of the most active landslide areas is the Palisades located in northeastern New Jersey along the Hudson River. Here, large rockfalls and rockslides occur along high cliffs formed of Triassic diabase (figs. 7 and 8). They are most common in the winter and spring after freeze-thaw cycles have loosened pieces of rock along joints and fractures. Surface water also seeps into joints or cracks in the rock, increasing the weight of the rock and causing expansion of joints when it freezes, thus prying blocks of rock away from the main cliff (Hansen, 1995).

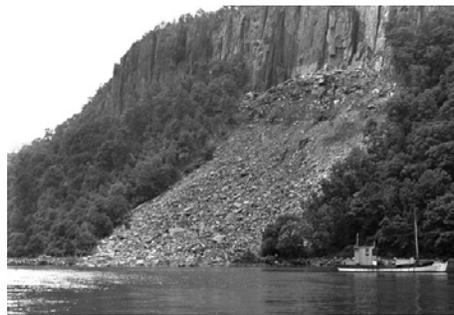
Figure 8. Rockslide north of Twombly's Landing, Alpine, 1938. Photograph courtesy of "Palisades Interstate Park - NJ Section."

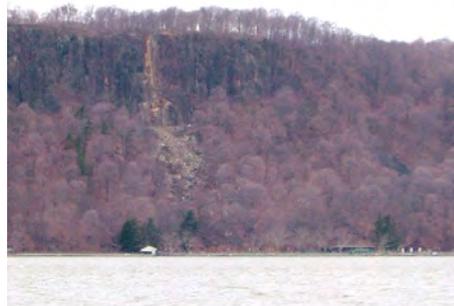
Figure 9. Photograph of the December 17, 2005, rockslide on the Alpine Approach Road in Alpine. Photograph courtesy of "Palisades Interstate Park - NJ Section."

A rockslide on December 17, 2005 occurred above the Alpine Boat Basin destroying approximately eighty feet of the Alpine Approach Road. The majority of the rockslide stopped at the boat basin parking area where it

demolished a cinderblock transformer shed. One large boulder bounced beyond the end of the slide landing in the Hudson River. The estimated cost for the cleanup and repairs from this rockslide was more than \$100,000 (Sangha 2006). There were no witnesses to this rockslide because it happened in the middle of the night (figs. 9 and 10).

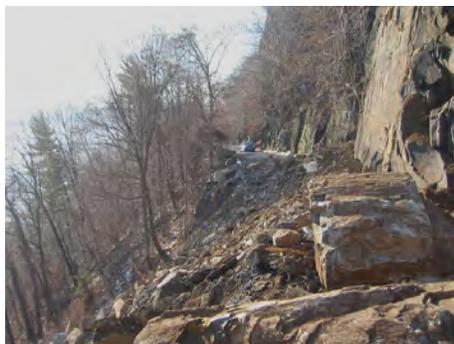
Figure 10. Photograph of the December 17, 2005, rockslide damage on the Alpine Approach Road in Alpine. Photograph courtesy of "Palisades Interstate Park - NJ Section."

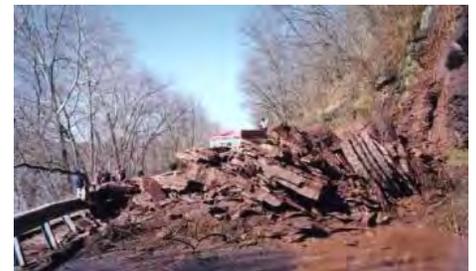
Figure 11. Photograph of February 29, 2000, rockslide on County Route 627 in Holland Township, Hunterdon County. Photograph courtesy of Hunterdon County Road Dept.

The fracturing of rock by frost heave caused a rockslide on County Route 627 north of Milford, Hunterdon County along the Delaware River in an area known locally as "The Narrows" (fig. 11). Large and small rockslides are an ongoing problem in this area.

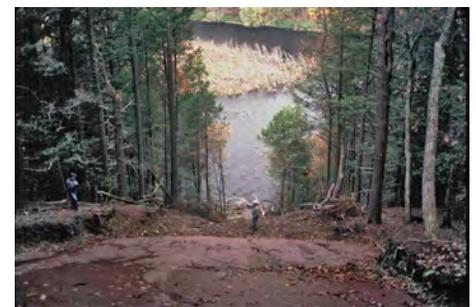
Figure 12. Photograph of a massive landslide in the Delaware Water Gap National Recreation Area, Hardwick Township, Warren County, New Jersey. Photograph by R. Witte, N.J. Geological Survey.

Heavy rain and excessive saturation of unconsolidated slope material triggers many landslides in New Jersey. During October 1995, a massive debris flow occurred just downstream from Wallpack Bend in Hardwick Township, Warren County (fig. 12). It was sited along the steep undercut northwest slope of Kittatinny Mountain at the outer bend of a meander of the Delaware River. Heavy rain (3.3 inches) fell near the site of the

landslide making the thin soil unstable and causing it to slide on the glacially polished bedrock surface. The slide area measured from 40 to 50

feet in width and 600 feet downslope, extending into the Delaware River an additional 60 feet. The total volume of soil displaced was calculated to be about 48,000 cubic feet (Epstein 2001). Figure 13 shows a smaller, but similar landslide in Hunterdon County. Here, thin soil and loose rock, slid off a steep slope of Triassic shale during a period of heavy rain, blocking Milford-Frenchtown Road.

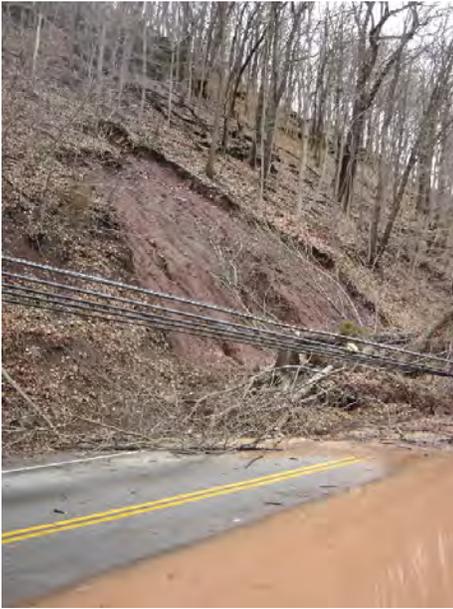
Figure 13. April 2005 landslide one mile south of Milford in Holland Township, Hunterdon County. Photograph courtesy of Hunterdon County Road Dept.

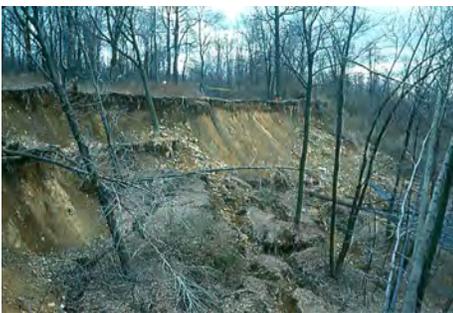
Figure 14. Landslide which destroyed Bellwood Farm Road, Bethlehem Township, Hunterdon County in 1989. Photograph by S. Stanford, N. J. Geological Survey.

In 1989, a 250 foot-wide slump occurred when a slope adjacent to a quarry failed in Bethlehem Township, Hunterdon County, causing Bellwood Farm Road to be destroyed and permanently closed (fig. 14). Approximately 2 acres of land collapsed at the edge of the quarry and the ground surface dropped nearly 60 feet at the site. As in this case, landslides can occur when the toe of a slope is removed.
